Manhole Inspection Summary

Manhole # S17CC_022MH

Insp Date: **10/19/07 1:03 PM**

Location Address: **1105 WHEELER-ALLEY-BENTALOU** Cross Street: **WINCHESTER-RIGGS**

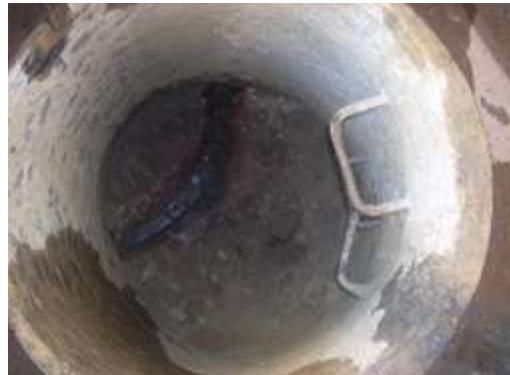
Top View

JOINT INFILTRATION

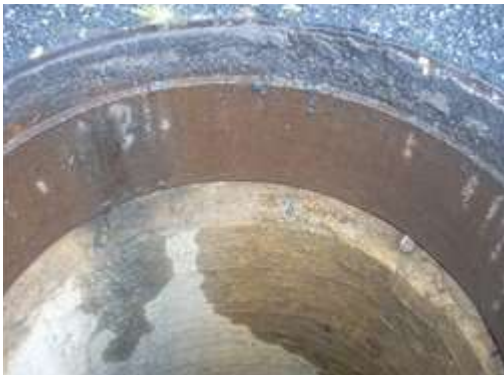
Defect 3

Infiltration: ☐ None ☒ **Joint** ☐ Cracks ☐ Mortar ☐ Roots ☐ Wall

JOINT INFILTRATION

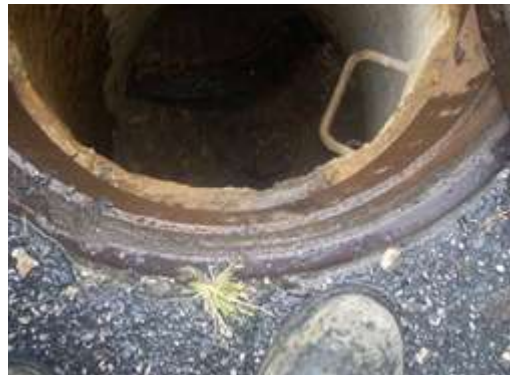
Defect 2

Frame Offset: **1** (in.) Condition: ☒ Sound ☐ Cracked ☐ Leaks

FRAME OFFSET

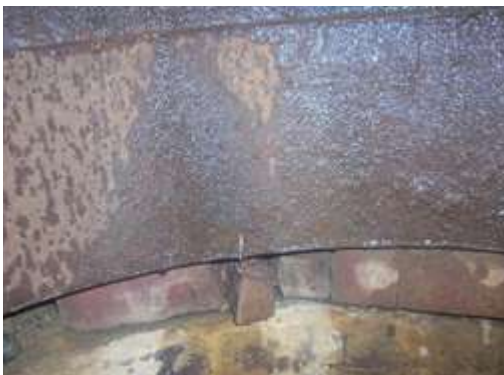
Defect 1

Condition: ☐ Sound ☐ Cracked ☐ Root Intrusion ☐ Loose Brick ☒ **Deteriorated**

DETERIORATED CHIMNEY

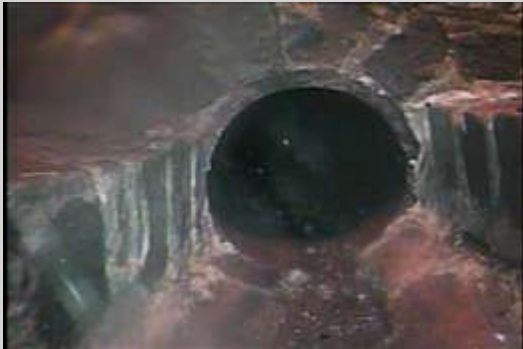
12 O'Clock Outflow

8 in. Circular Gravity Sewer
Pipe Out @ 12 O'Clock

Pipe Height: **7.2** (in.) Rod and Bar (Angled)
Pipe Material: **Clay** ☐ Pipe Lined
Invert Depth: **7.49** (ft.) Flow Characteristics: **None**
Deposits: ☒ None ☐ Mud ☐ Sludge ☐ Debris ☐ Grease
Silt Depth: (in.) Deposits Extent:
Infiltration: **None** Pipe Seal Cond: **Sound**

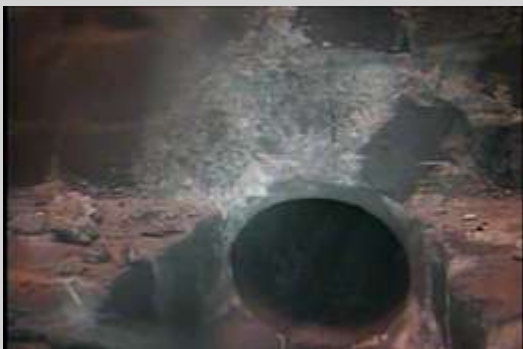
8 O'Clock Inflow

6 in. Circular Gravity Sewer
Pipe In @ 8 O'Clock

Pipe Height: **6** (in.) Rod and Bar (Angled)
Pipe Material: **Clay** ☐ Pipe Lined
Invert Depth: **7.20** (ft.) Flow Characteristics: **None**
Deposits: ☒ None ☐ Mud ☐ Sludge ☐ Debris ☐ Grease
Silt Depth: (in.) Deposits Extent:
Infiltration: **None** Pipe Seal Cond: **Sound**
